Rock Ahoy!

The grounding of the Waters.

By PETTY OFFICER SARA FRANCIS
U.S. Coast Guard, 17th District Office of Public Affairs

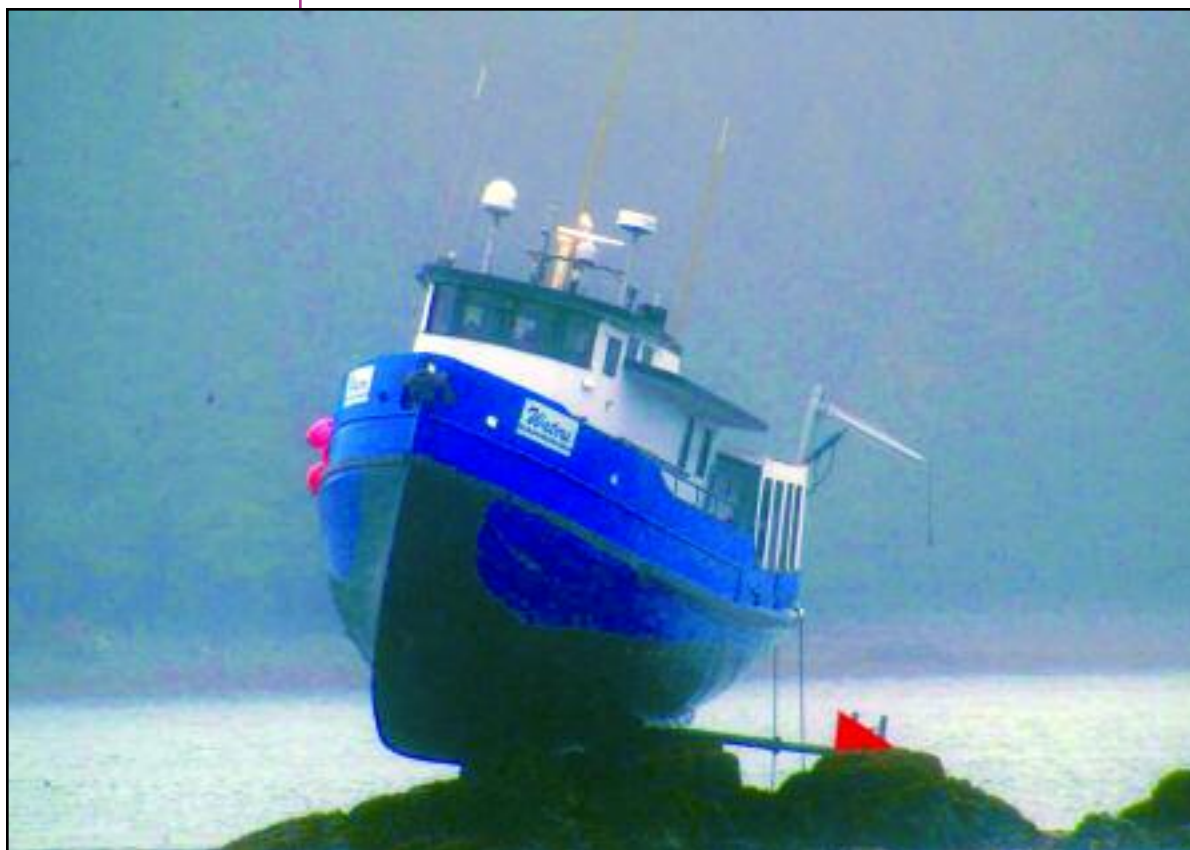
Figure 1: The *Waters*, aground. Petty Officer Sara Francis, USCG.

rent prevented steering and put too much strain on the tow-line. Finally—several days after the grounding—the tug *Kodiak King* got the *Waters* off the rock in a nine-foot tide. The damage consisted of an inch-deep penetration in the hull, caused by the dayboard's stub. Water seeped through the damaged caulking. Divers from the nearby village made temporary repairs, and the *Waters* sailed to Kodiak, where the staff at Fuller's Boatyard hauled it out and replaced the broken board.

To prevent future accidents, Wiley contacted NOAA and suggested providing additional information about the currents in the *Coast Pilot*. Until the updated version of the *Coast Pilot* becomes available, the best advice for recreational boaters is to pay attention to tidal charts, watch the currents, and sail only with good visibility.
